# ERROR CODES

## Error No. 05

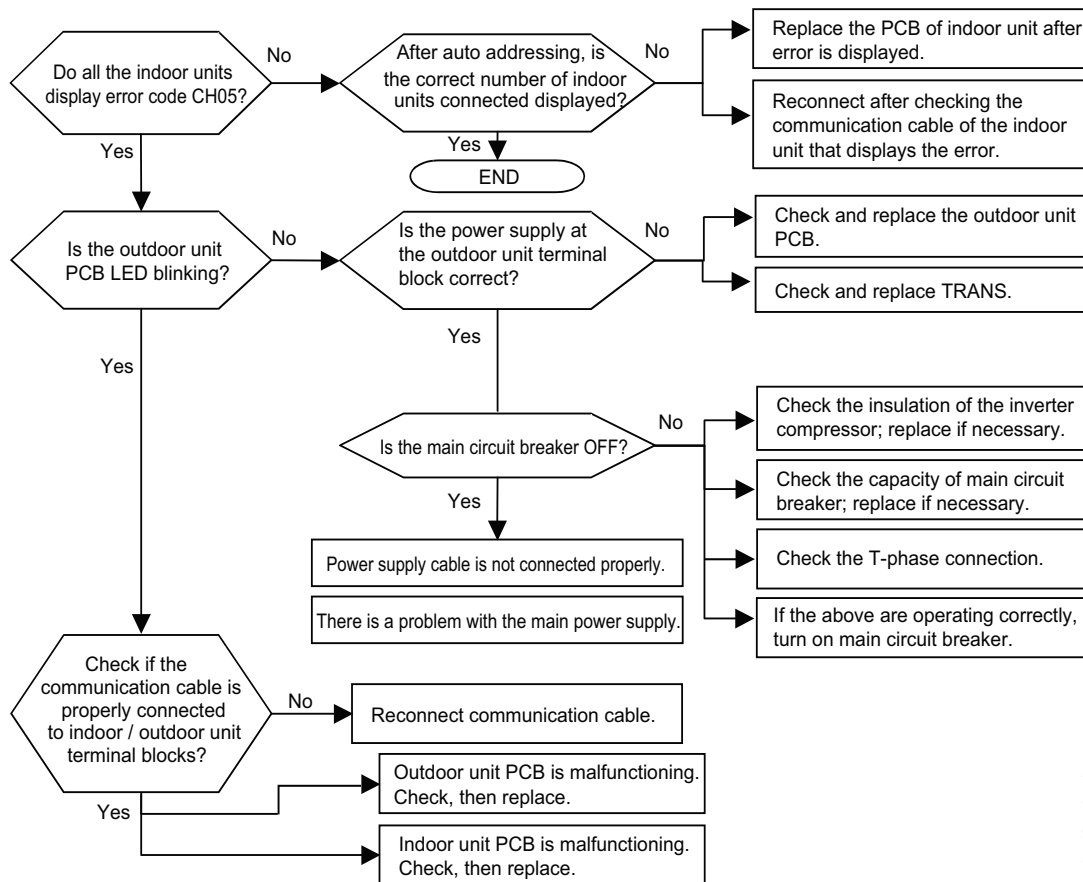
Error No.	Description	Details	Causes
05	Communication error between outdoor unit PCB and indoor unit PCB.	Indoor unit PCB is not receiving communications signal from outdoor unit PCB for more than 5 minutes. Check indoor unit PCB for issues.	<ol style="list-style-type: none"> <li>1. Auto addressing has not been performed properly.</li> <li>2. Communication cable is not connected.</li> <li>3. Communication cable is short circuiting.</li> <li>4. Indoor unit communication circuit error.</li> <li>5. Outdoor unit communication circuit error.</li> <li>6. Not enough physical distance between power wiring and communication cables.</li> <li>7. T-phase line disconnection.</li> </ol>

Images here are representative of system components. Actual component appearance depends on model and system type.

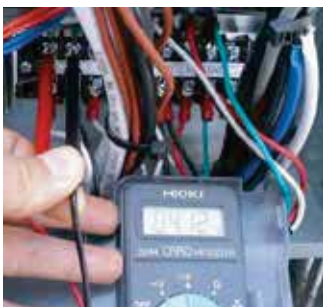
Communication from the indoor unit is normal if voltage fluctuation (-9V ~ +9V) exists (when checking DC voltage of the communication terminal between the indoor and outdoor units).

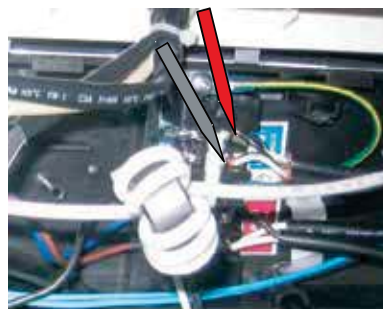
If the DC voltage between communication terminal A, B of indoor unit fluctuates within -9V ~ +9V, then the communication from the outdoor unit is normal.
